## SICHERHEITSMITTEILUNG für Gurtzeuge

Nummer: 01/2019

## Product Service Bulletin

**ISSUE DATE:** March 30<sup>th</sup> 2019  
**Bulletin Number:** FB 2019-01  
**SUBJECT:** Reserve pin ripcord assemblies on Firebird EVO Harness Containers  
**STATUS:** **MANDATORY BEFORE NEXT JUMP**  
**Affected HC:** All Firebird EVO HC with Pillow Ripcord assemblies PN 012 built between April 2018-March 2019, Serial numbers BD 001-CB 010  
**To:** All Firebird Dealers and Customers

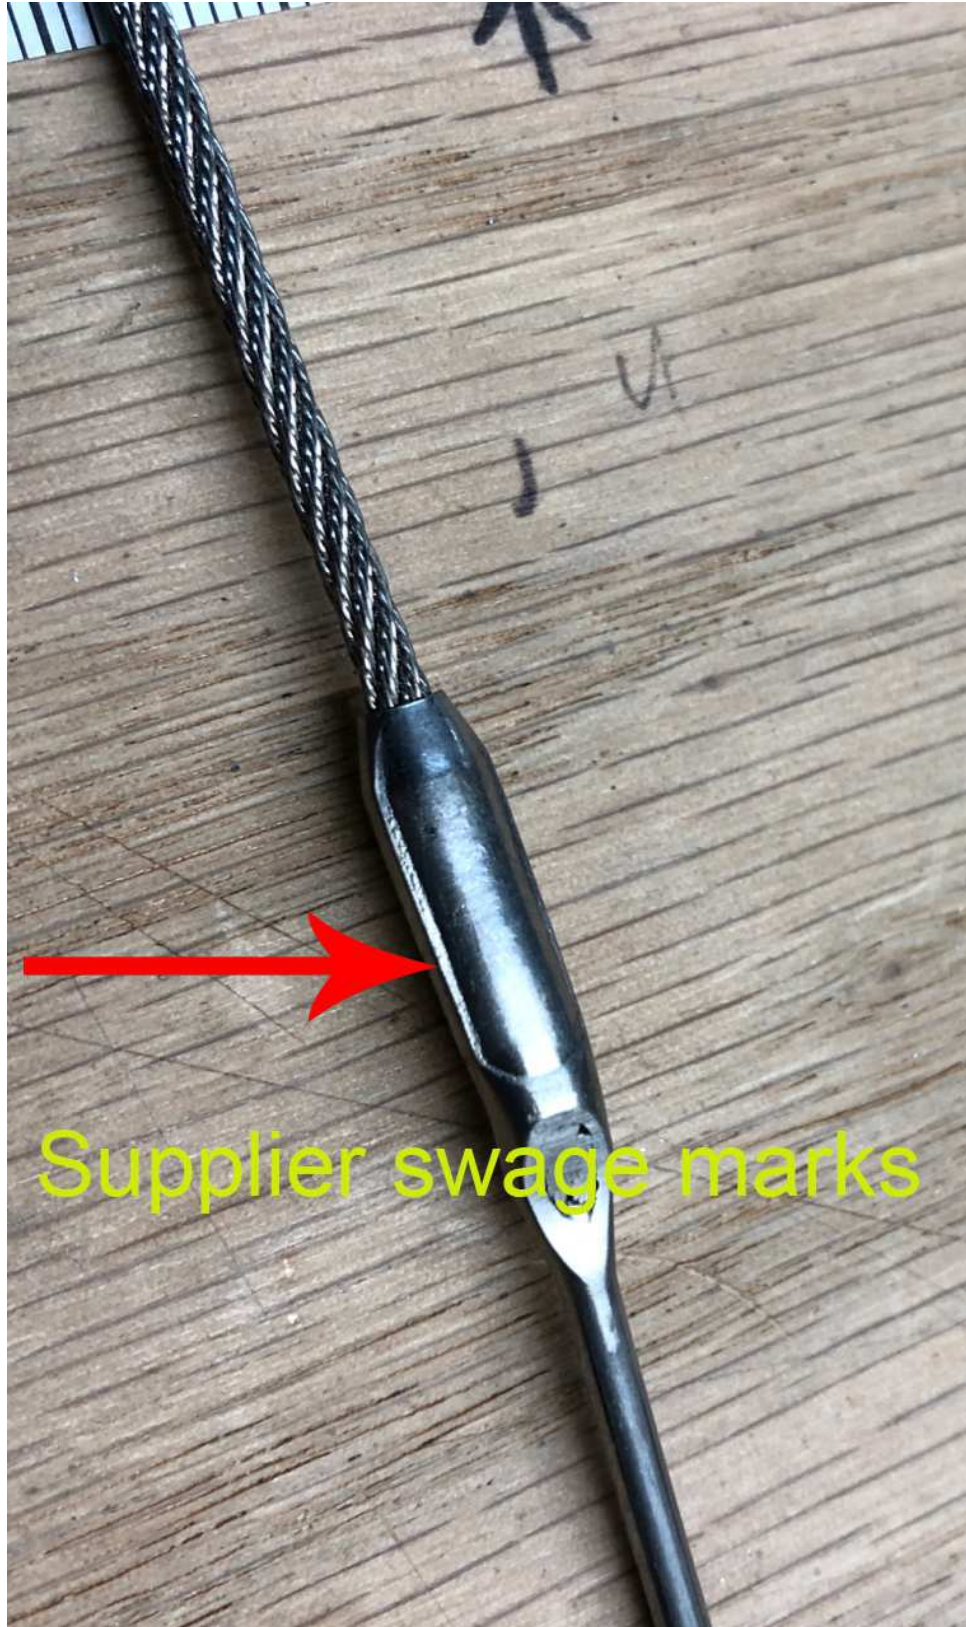
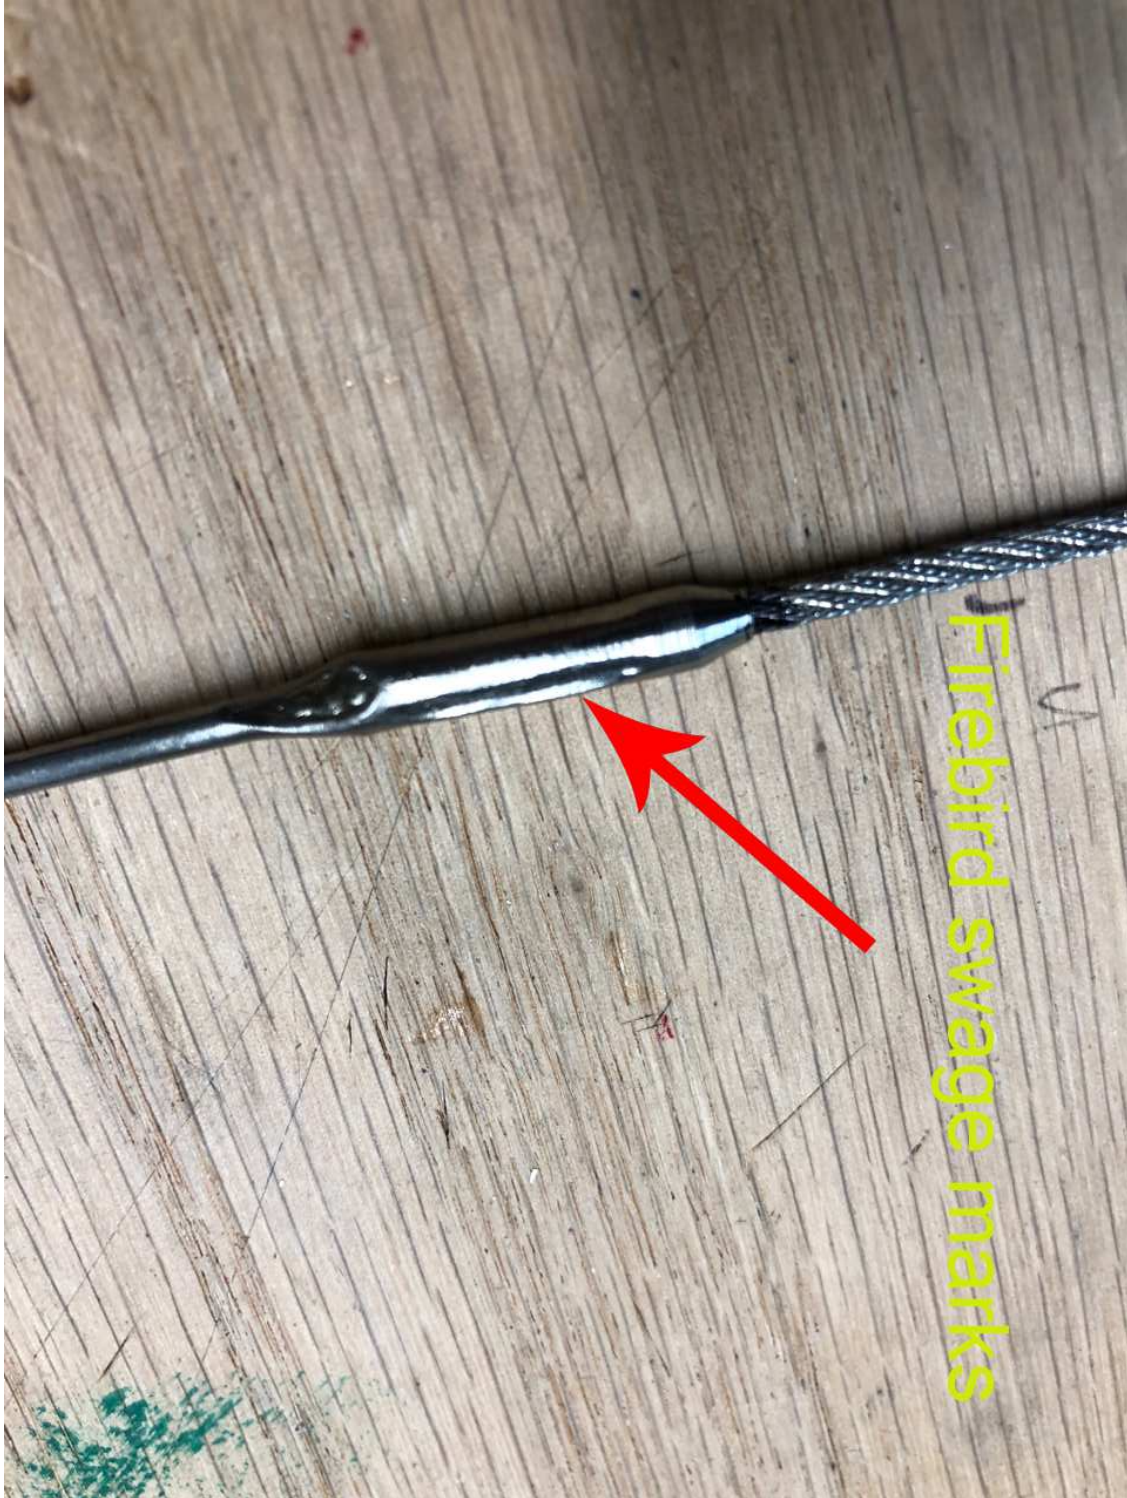
If your HC has a ripcord pillow ripcord assembly installed between SN BD001 and CB010 they have to be visually inspected for swaging marks.

If your reserve pin doesn't have clear swage marks as pictured, DO NOT JUMP until notification and further inspection through Firebird USA LLC.

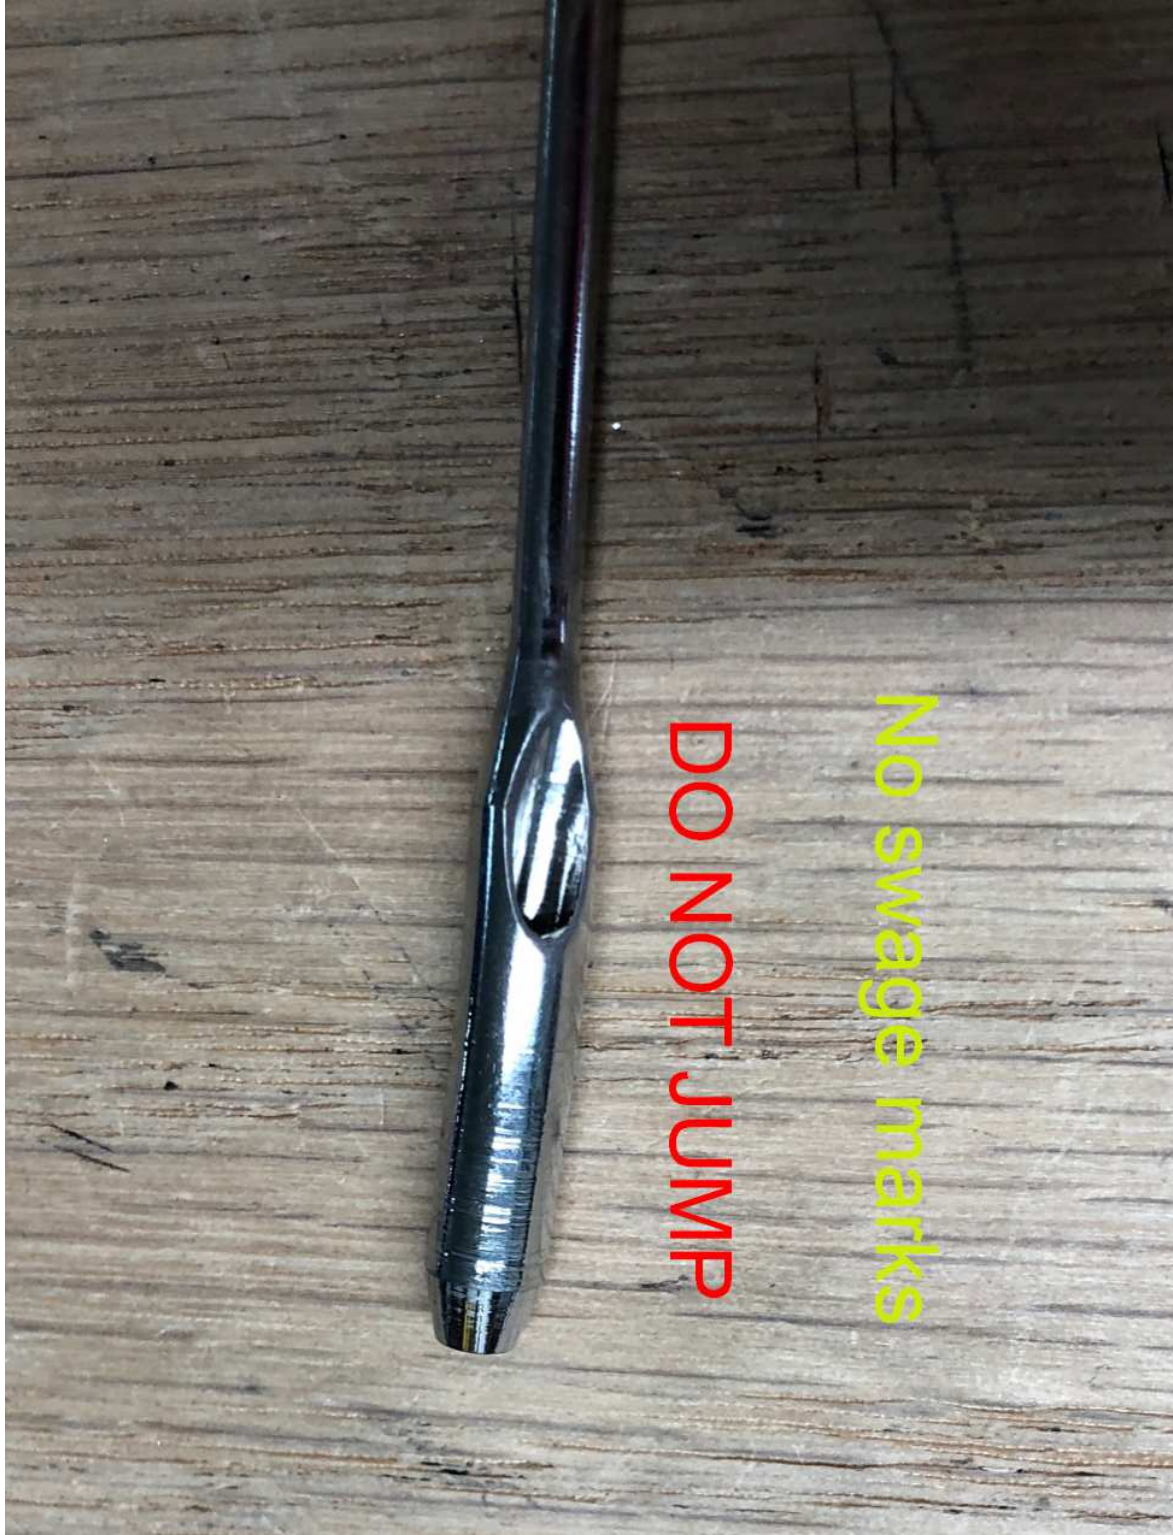
DO NOT JUMP

No swage marks

Contact Firebird per phone +1 7473008880 to arrange shipping of a new ripcord at no charge. You can send us pictures per email at [usa@flyfirebird.com](mailto:usa@flyfirebird.com). Furthermore, the supplier agreed to pull test any ripcord that any customer wants tested.
